# Manhole Inspection Summary

Manhole # S37A2\_001MH

Insp Date: **5/5/08 10:46 AM**

**Location** Address: **306 E. Jeffrey St.**

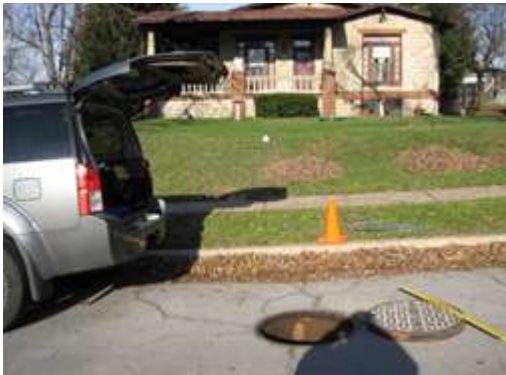
Location View

306 Jeffrey

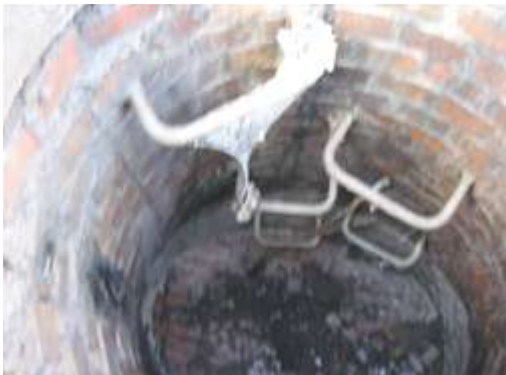
Steps

Count: **5** Missing: **0** ☒ **Corroded**

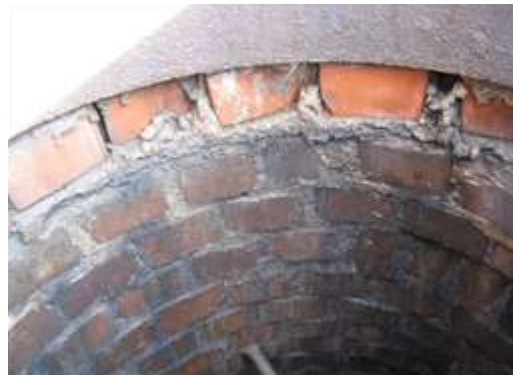
Defect 1

Condition: ☐ Sound ☒ **Cracked** ☐ Root Intrusion ☐ Loose Brick ☐ Deteriorated

Infiltration: ☐ None ☐ Joint ☒ **Cracks** ☐ Mortar ☐ Roots ☐ Wall

Chimney

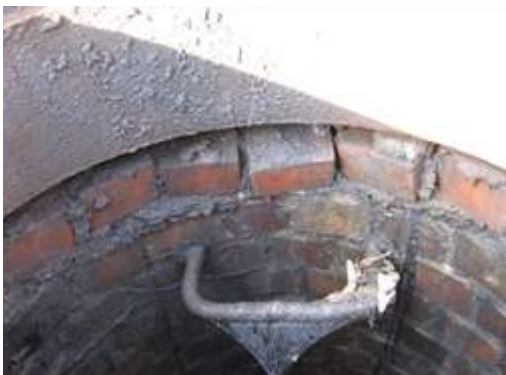
Defect 2

Chimney/Evidence of Surge

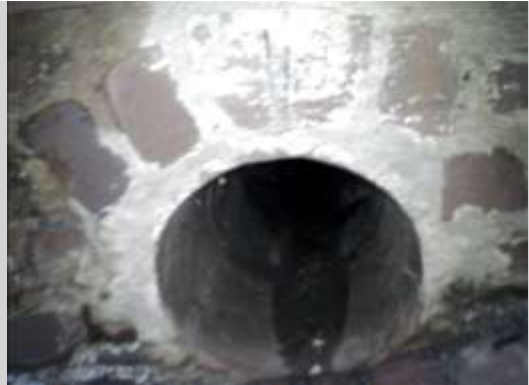
12 O'Clock Outflow

8 in. Circular Gravity Sewer  
Pipe Out @ 12 O'Clock

Pipe Height: **10.8** (in.) Rod and Bar (Angled)

Pipe Material: **Clay** ☐ Pipe Lined

Invert Depth: **7.86** (ft.) Flow Characteristics: **None**

Infiltration: **None** Pipe Seal Cond: **Sound**
